Norton Hall – The Previous One

Tony Spillane
21st October 2019

- The current Norton Hall dates from approx. 1832
- It has evolved over time, with additions on the western side, and an orangery to the north west corner.
- It has cellars which may pre-date the building in certain areas, and there is a closed off door within the cellars which might go beyond the current building's layout.
- There currently exists a churchyard boundary wall which includes a stone window frame, potentially from an earlier building.
- These features, and various maps and pictures have been studied to try to identify the "Previous Norton Hall"

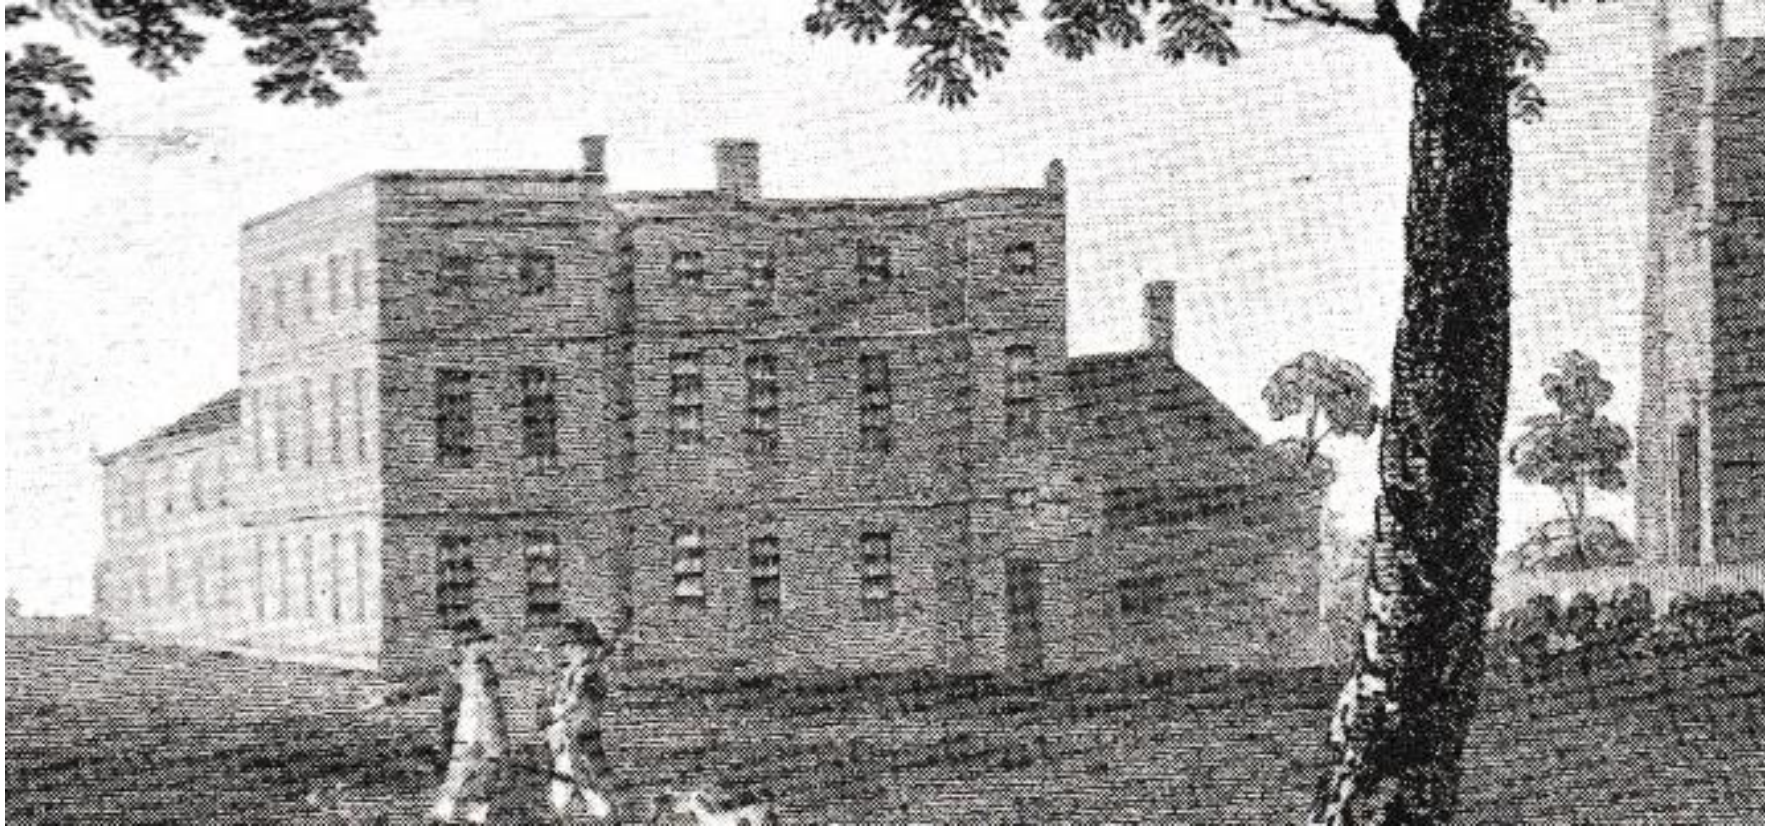
Image dated 1793 from “Chantreyland” book.

Very regular window sizes and layouts in main square block.

Pitched roof building to right hand side (eastern side) of building, towards Norton Church.

No stone wall visible between Hall and Church.

- The main part of the “Previous Hall” was the square block, to the south west corner.
- It had a flat roof, three stories, and visible horizontal ridged features between each storey.
- There was some sort of recess mid way along the south facing wall, although the magnitude varies between the two images
- The window layout is very different between the two images, suggesting either significant building work (unlikely, as the older image has the better windows), or unreliability on the part of the image creator(s)
- Both images show a pitched roof building on the eastern side of the building, adjacent to the church.

The window frame appears very low, however there is a difference in ground level each side of the wall. This is also visible in the 1793 image.

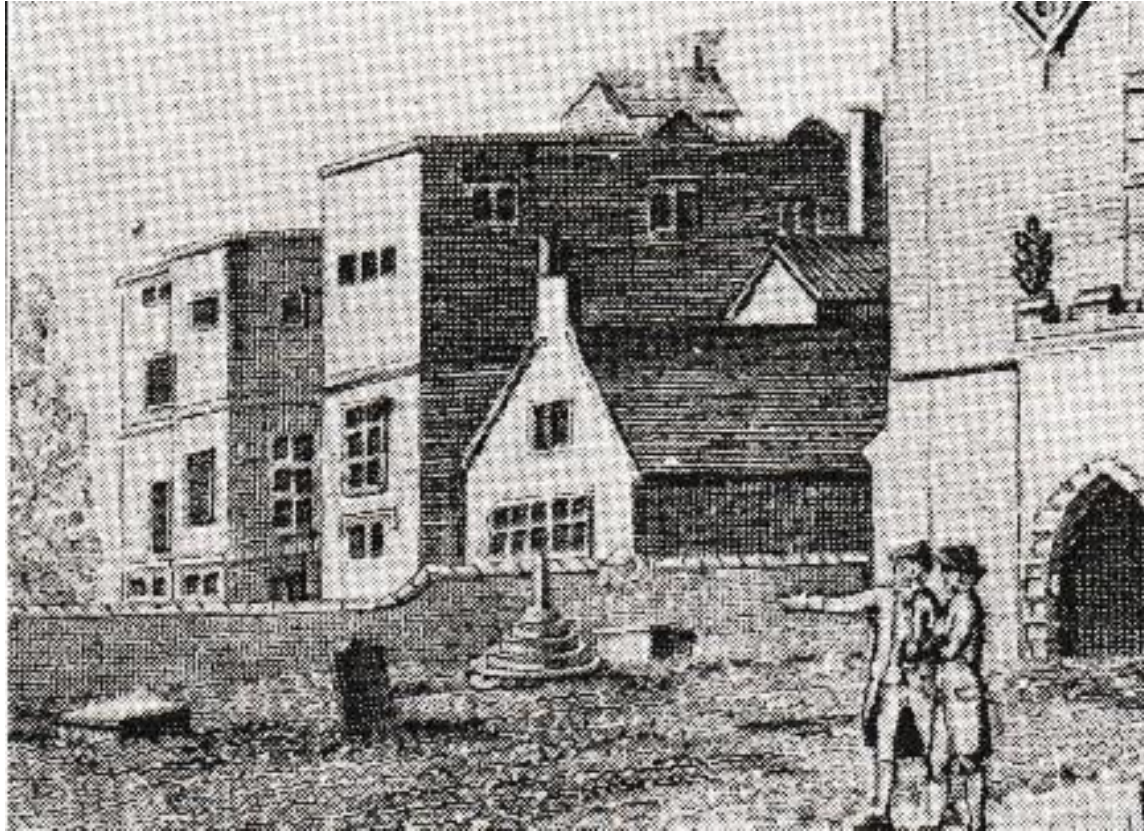
Image dated Circa 1800, from “Chantreyland” book.

Windows very irregular in size and location.

Pitched roof building to right hand side (Eastern side) of building, adjacent to Norton Church

Stone wall clearly visible between Hall and Church, with dip in height part way along

Small stone tower subsequently re-located to allow for Chantrey’s grave

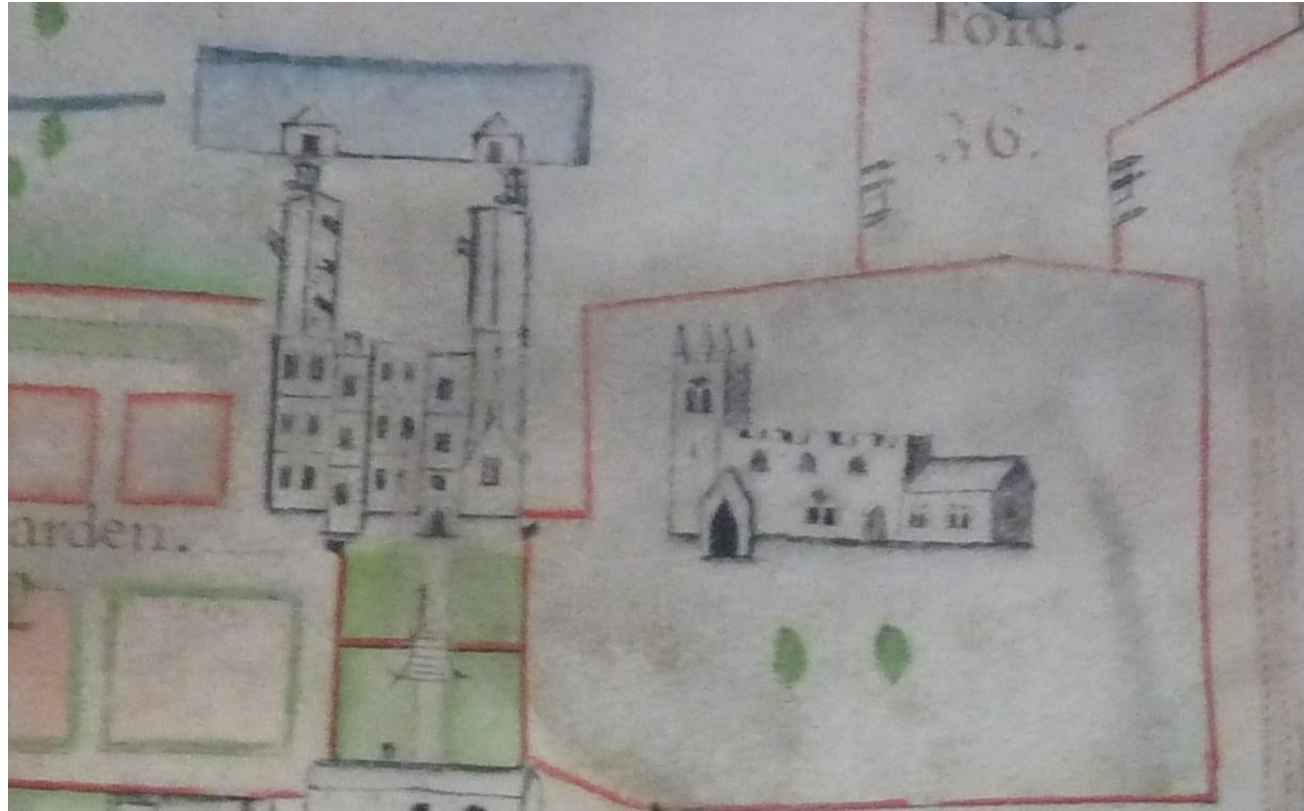
This map (part layout, part isometric) is dated 1741.

It shows the three storey 'square block' with regular windows, and a very long pitched roof building on the eastern side.

The eastern side of the Hall doesn't appear to reach the churchyard boundary.

The southern wall is almost in line with the southern wall of the church.

Although the church has a boundary, it is not possible to deduce the form of it.

- The “Previous Norton Hall” was located close to the Norton Church (much closer than the current Hall), with the southern walls in line (the 1775 map contains a positional error, as the Hall couldn’t move fifty feet north, and then fifty feet back again!)

- The 1741 map shows some ornate gardens to the south and west of the Hall, but these are not shown on the 1775 map, despite trees and paths being shown. This implies that they fell into disuse.

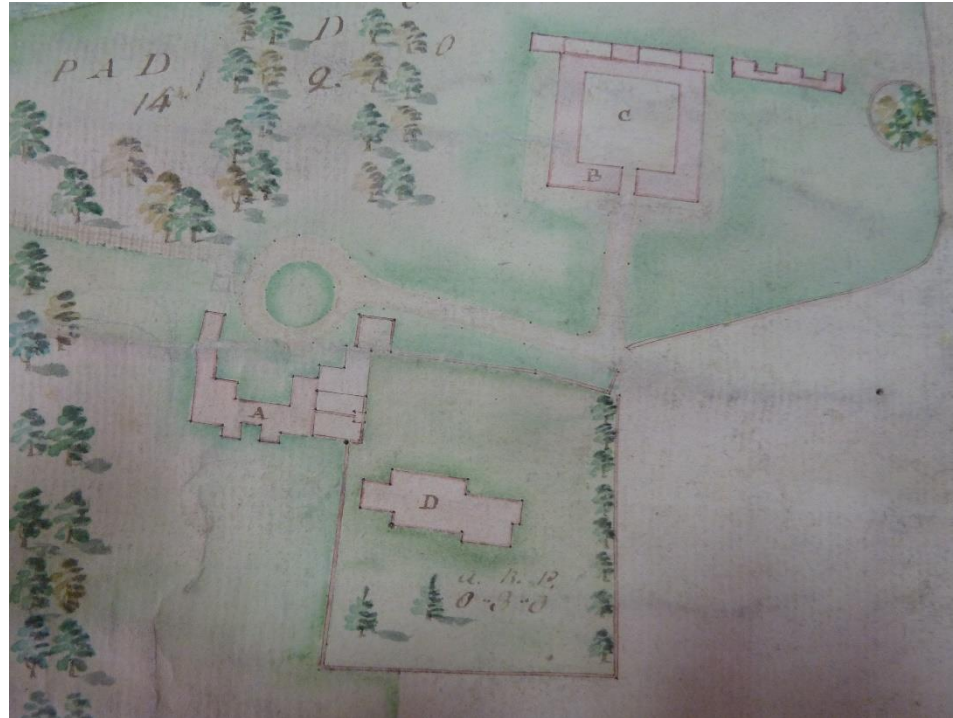
This map is dated 1775.

The main feature is that the Hall appears to be further north than shown in the other maps (the southern walls are no near aligned between Hall and Church)

The pitched roof building on the eastern side now appears to have a number of separate roofs, with possibly a chimney.

The eastern edge of the Hall now runs along the churchyard boundary

- There is evidence of building change, particularly to the eastern pitched roof part of the building.
- The main entrance appears to be to the northern side, where there is a natural courtyard. The 1775 maps shows a roundabout and entrance way to the north, with a connection to the stables.

- Both the 1775 and the 1803 maps show some sort of structure (out-building?) to the north east corner, on the outside of the churchyard boundary corner. It is not shaded on the 1803 map, implying that it is not a main part of the building.

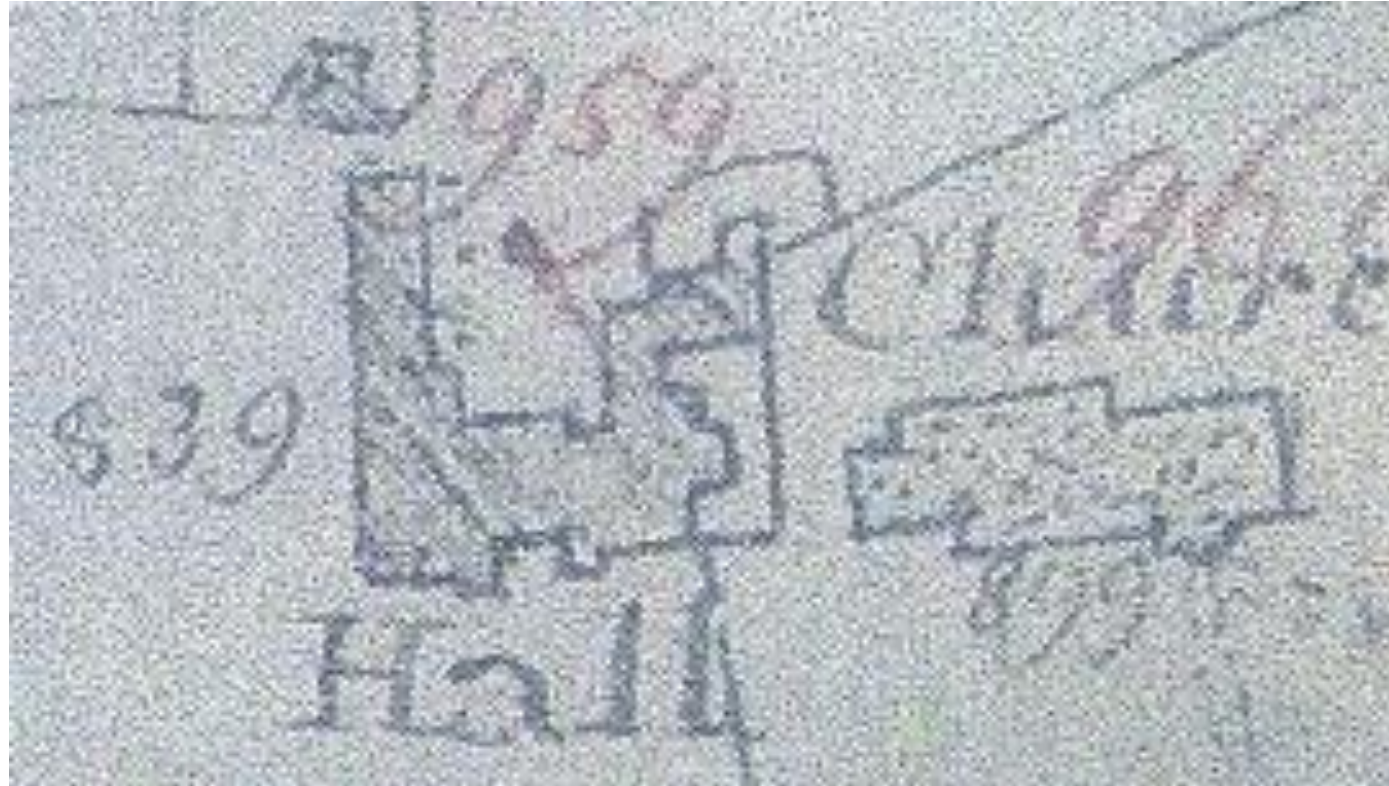
This map is dated 1803. The southern walls of the Hall and the Church are now in line again. The Hall outline is quite detailed, therefore giving some credence to the layout. The south eastern end, under the pitched roof, now appears to have an irregular floorplan, suggesting that some building work has been done. The north eastern corner is still abutting the churchyard boundary, which is where the stone window frame still exists (see later).

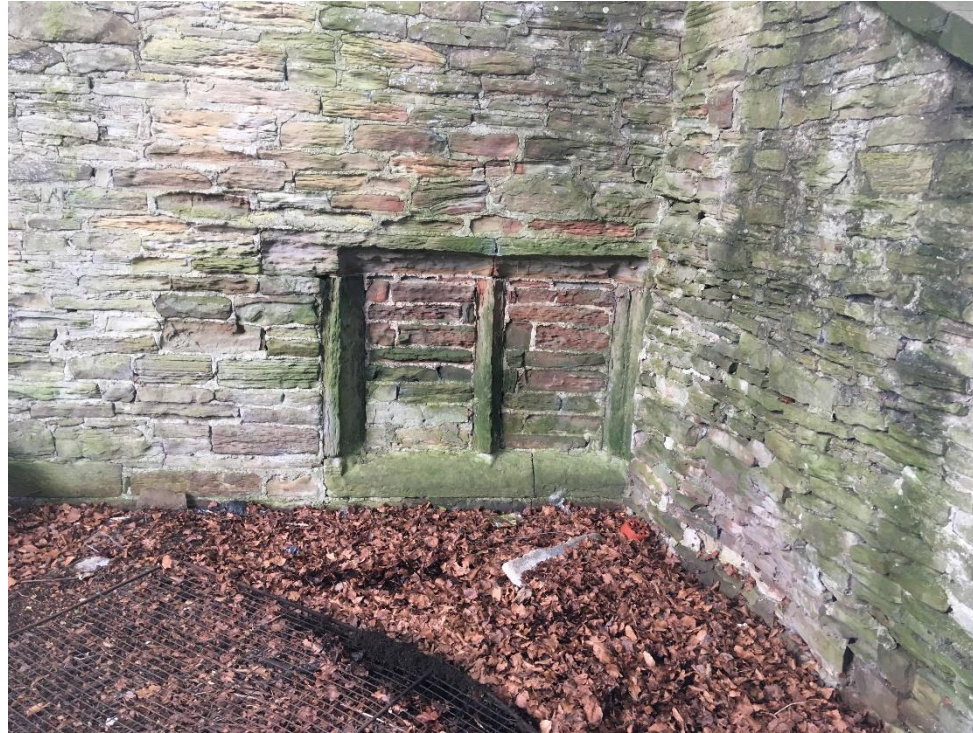
This photo shows the stone window frame still in-situ in the churchyard boundary wall.

It is now fairly clear that this wall was the eastern edge of the pitched roof part of the “Previous Norton Hall”
The wall at 90 degrees (on the right hand side of the photo) is also churchyard boundary wall, and on the other side of this would have been the previously mentioned possible out-building.

Apparently there is still a second stone window frame further along the wall, but it is obscured by modern items leaning against the wall.

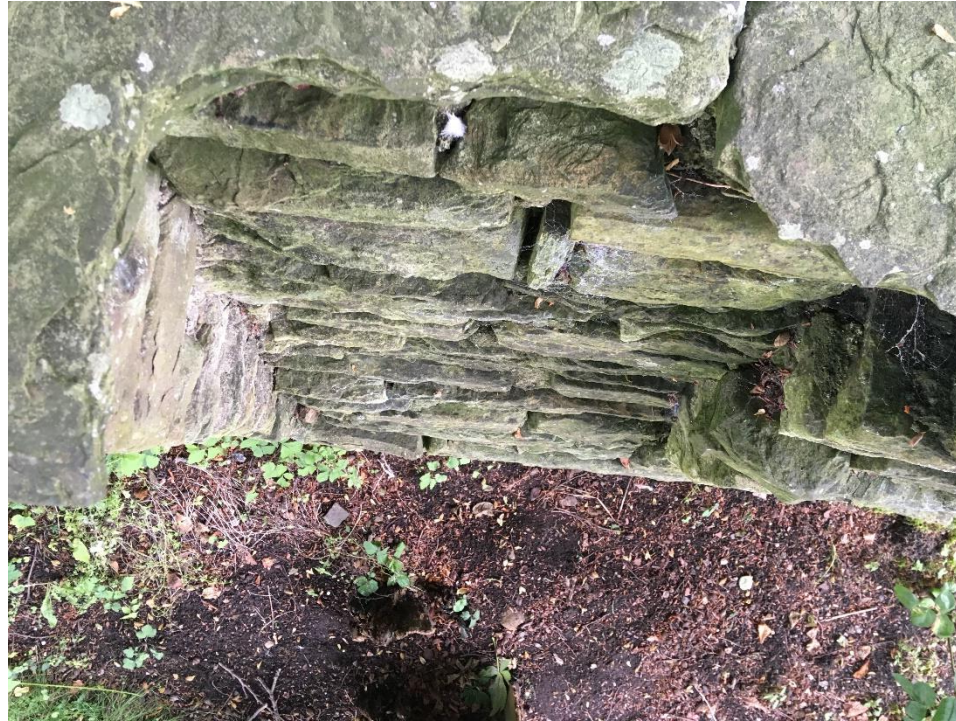
The churchyard boundary wall is now made of two layers (hence the window frame is blocked off). The second layer (effectively inside the pitched roof part of the building) contains a couple of interesting features. These are vertical rectangular steps in the wall, that taper from nothing at ground level, to their maximum at the top of the wall (see photo, taken from above looking downwards)

This appears to give clearance to a rectangular vertical structure, eg a timber crook archway / roof structure. There are two or three of these features along the length of the wall where the pitch roofed structure would have been.
