# **Norton Stone Wall Damage**

Tony Spillane  
1<sup>st</sup> March 2023

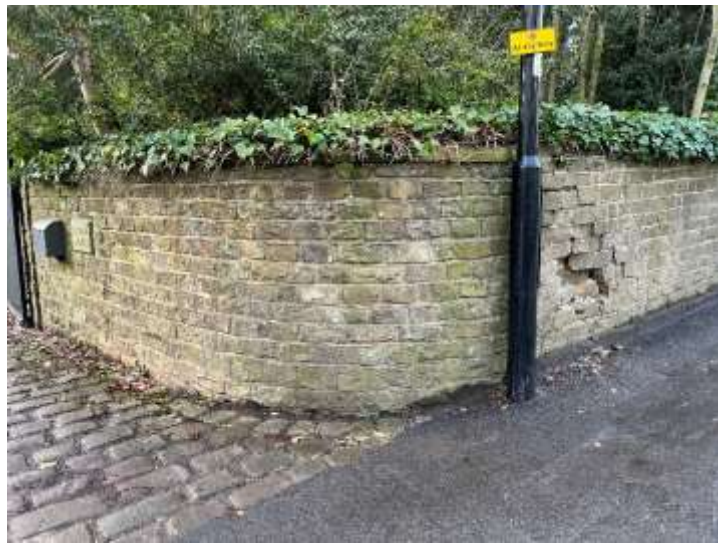
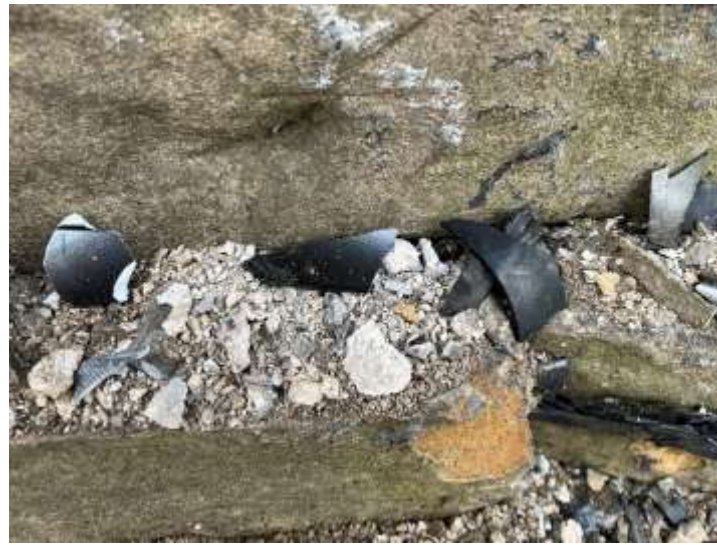
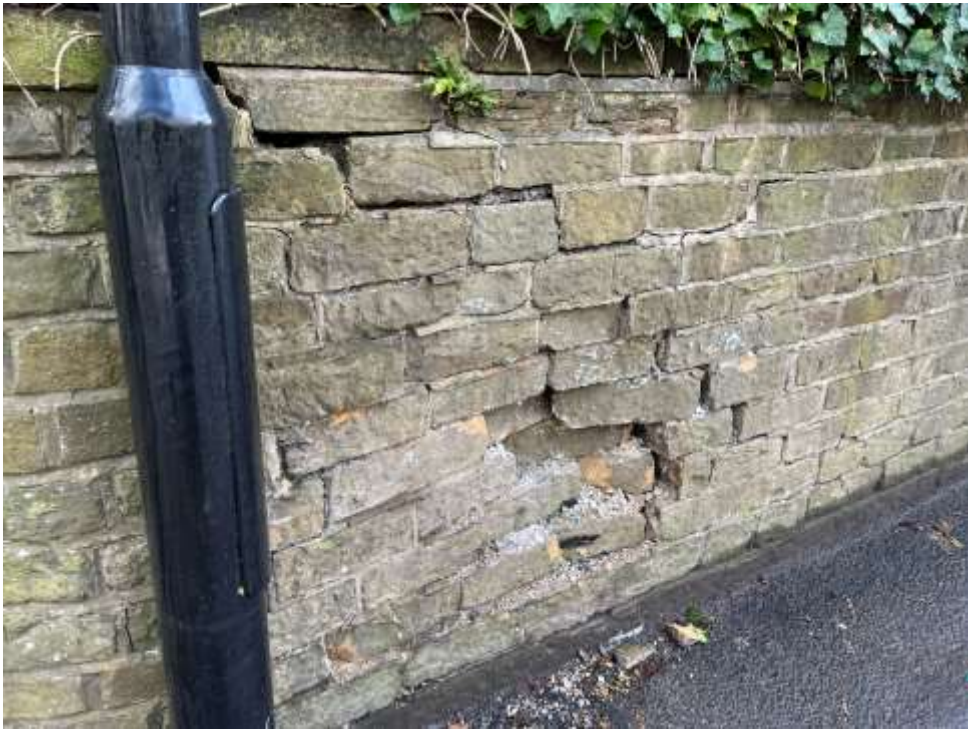
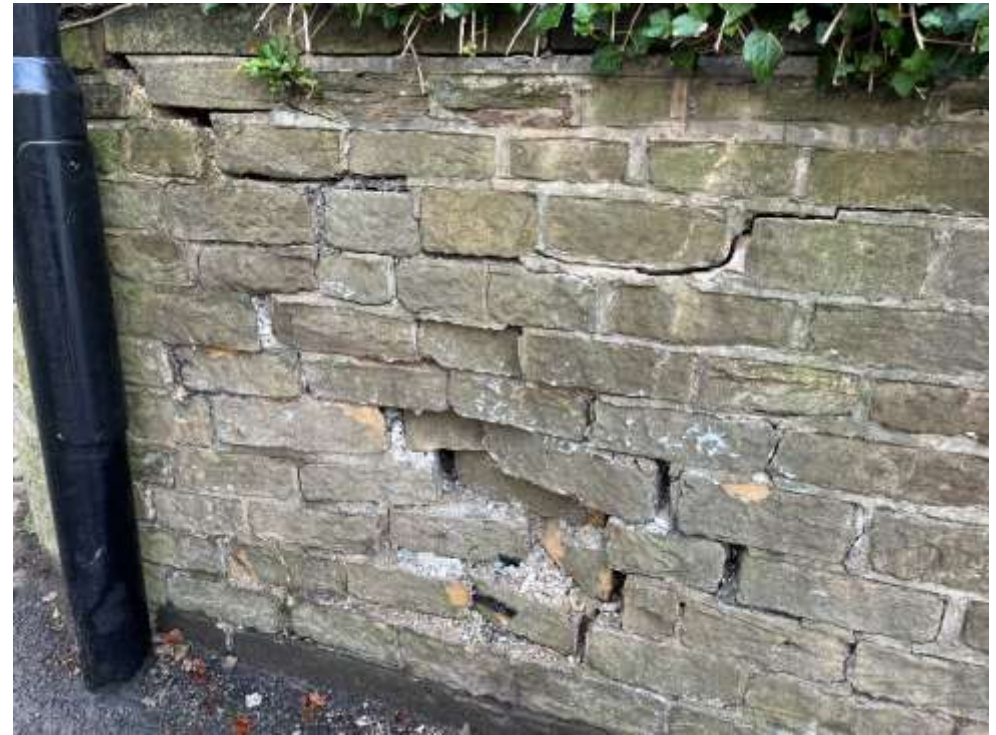
## **Damage No. 1 - Chantry Cottage entrance**

- The impact height appears to be approx. one and a half foot high, and was caused by a car or light van.
- There are small remains of both self coloured black plastic, and grey coated plastic, both probably from the vehicle's plastic bumpers.
- The impact damage to the wall appears to be fairly localised, suggesting a strong structural element (such as a steel bumper bar) that has caused the damage to the wall.

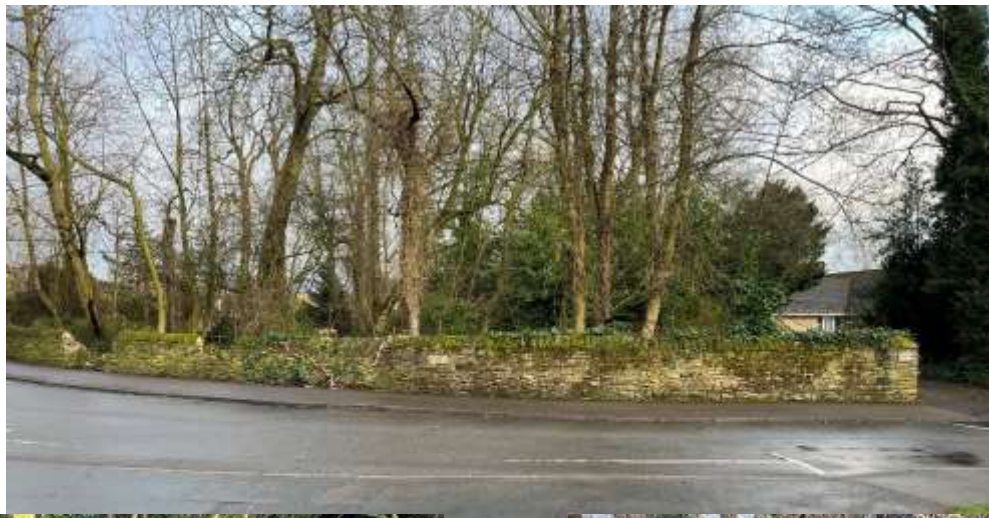
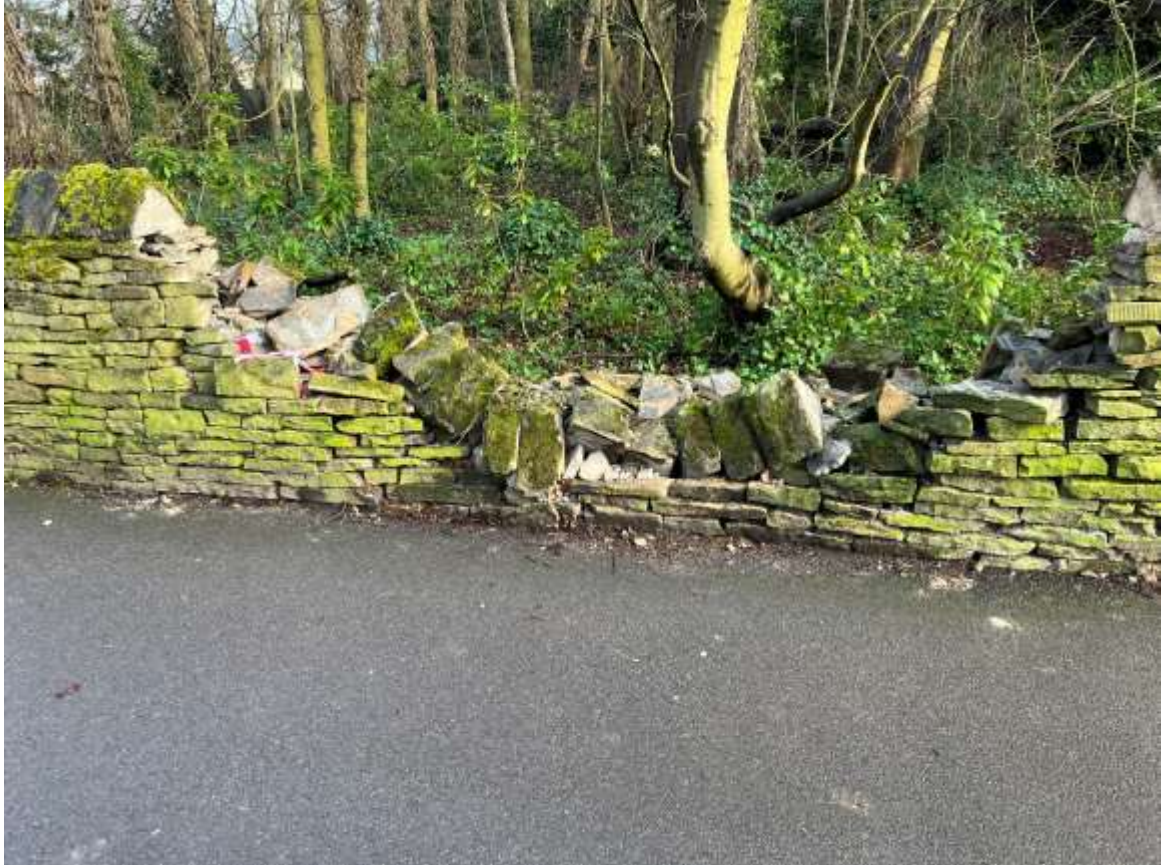
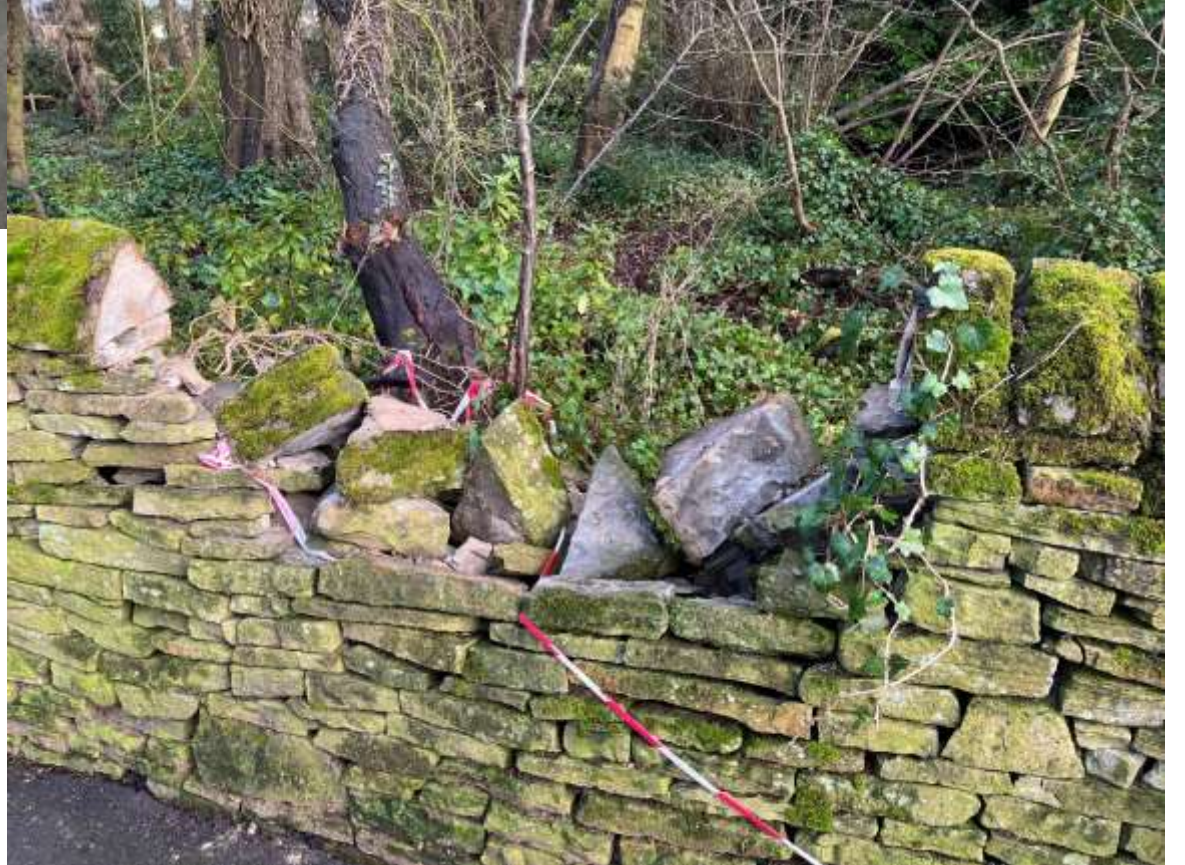
## Damage No. 2 & 3 - Wall of the Norton Rectory

- The damage here is more extensive, as sections of the wall have collapsed, with stones being pushed into the grounds of the Rectory.
- The height of the impact must be approximately half the height of the wall, as these stones have been pushed the furthest.
- In contrast, the triangular stones at the top of the wall have just dropped vertically down, and are still in their original alignment.
- One of these damage locations is more severe than the other, even though they are very close to each other.
- If my memory is correct, one damage location was created a few days / weeks before the other.
- There doesn't appear to be debris from the vehicle or whatever caused the damage, although someone has (usefully!) put some red & white tape up.
