Old Stone Stiles

Two sets of stones have been found on our walks with the Meadowhead Military local history group. They both consist of two vertical stones, each with a groove carved into its inner face, giving provision for a vertically orientated flat stone to be placed in the grooves.

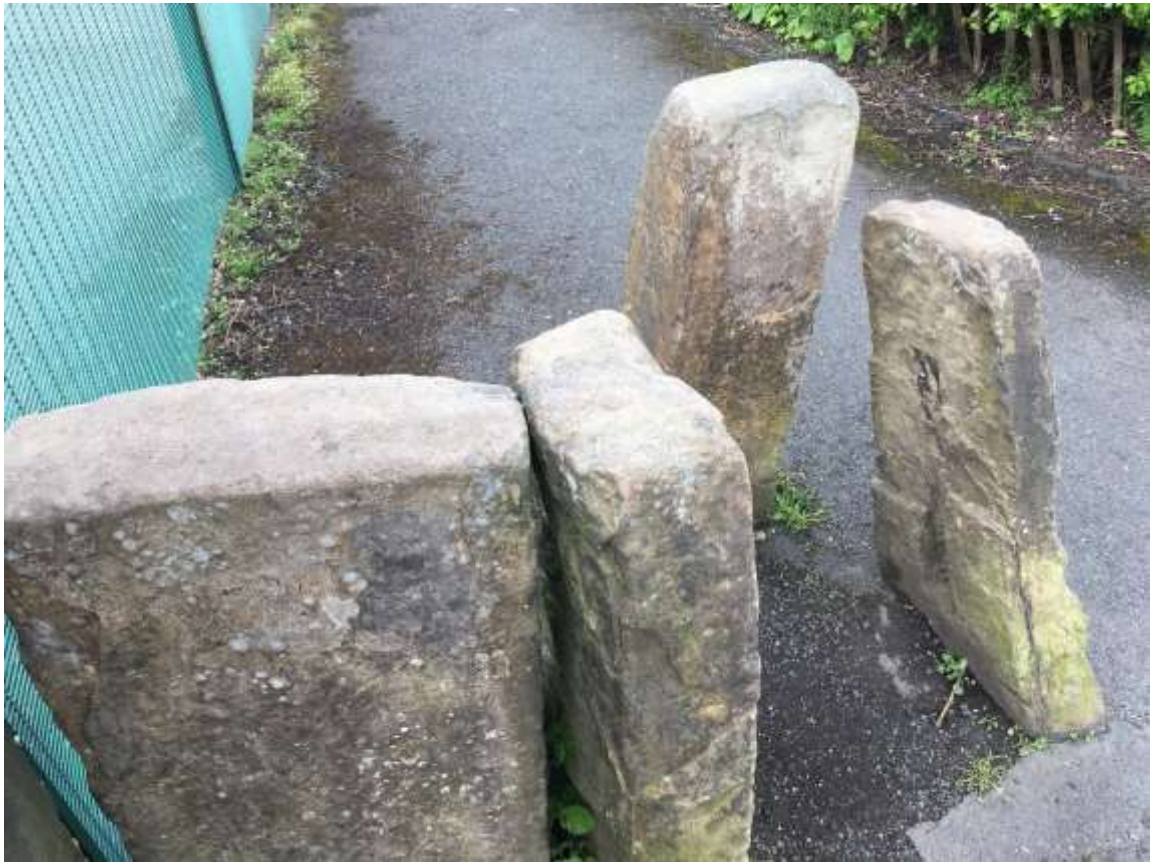
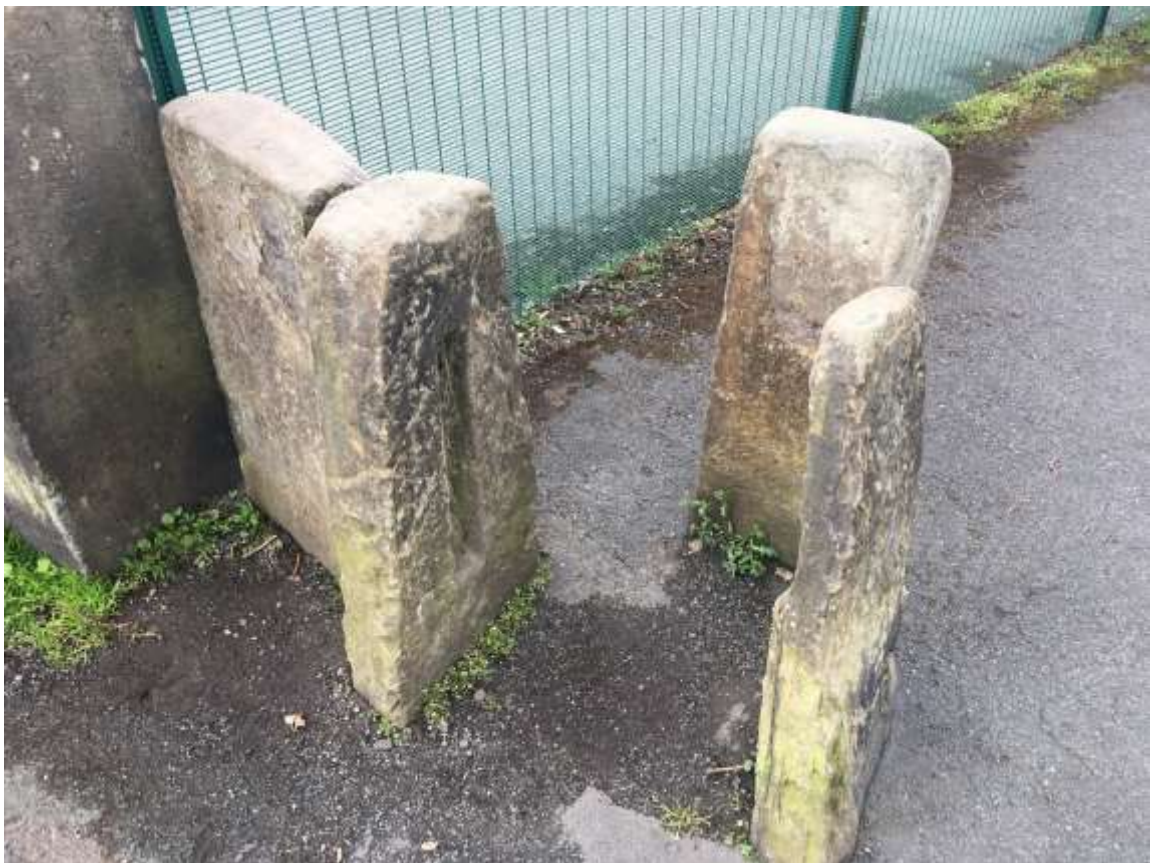
1) Matthews Lane / footpath

The two vertical posts facing each other have both got a groove chiselled into their inner surfaces, but the grooves do not go to the top. Originally, there would have been a flat stone fitted into the two grooves, over which people would have had to step. There may have been stepping stones either side, to assist getting across the stile.

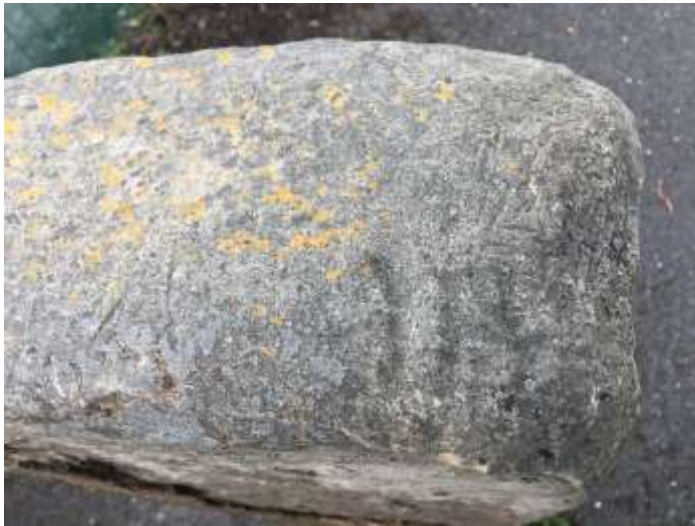
There is a third vertical stone, to make getting across the stile more awkward (perhaps to deter animals from trying to jump over?). On the top of this vertical stone, there are some markings:-

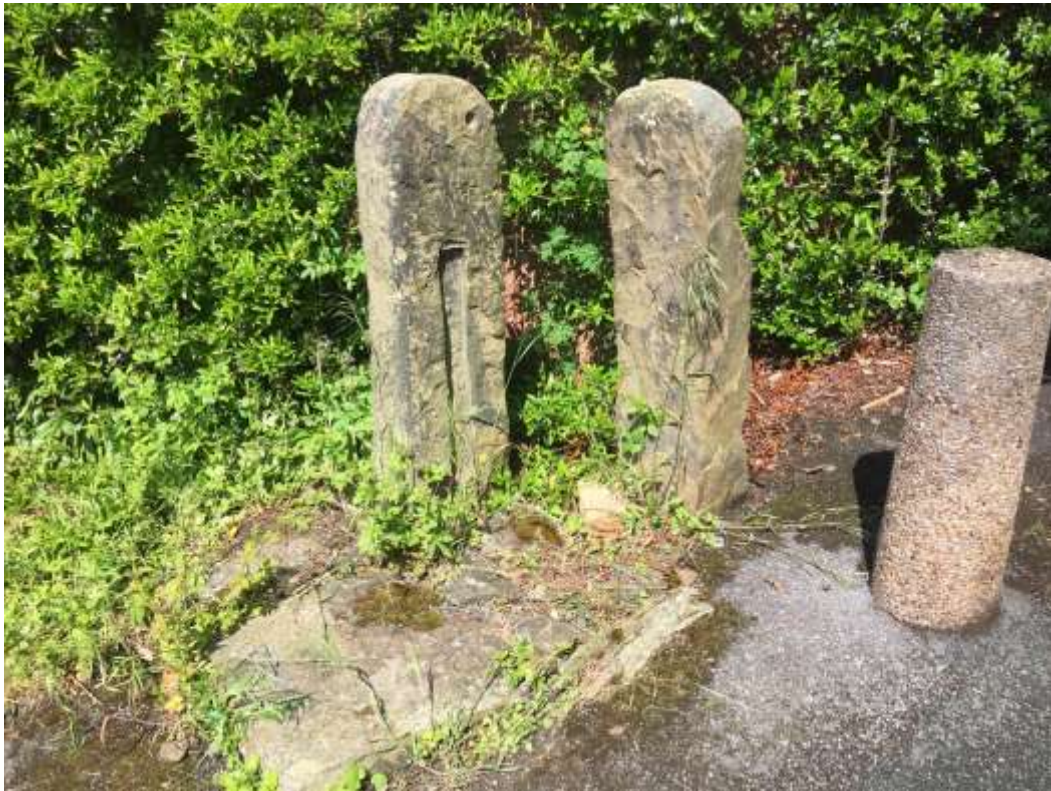
2) Footpath junction by Chancet Wood Rise / Meadow Head Drive

On the entrance to one of the footpaths there is a stone stile, of the same construction as the previous one in Matthews Lane. However, the vertical stone posts do seem to be taller here.

The round concrete post is obviously a much more recent addition, so it can be ignored. The remains of the missing vertical stone post can be seen in the ground as a stump. It would have provided the opposite groove for the vertical flat stone.

It is possible that one of the vertical posts was crudely broken and knocked down to release the vertical flat stone, when the stile was no longer needed.

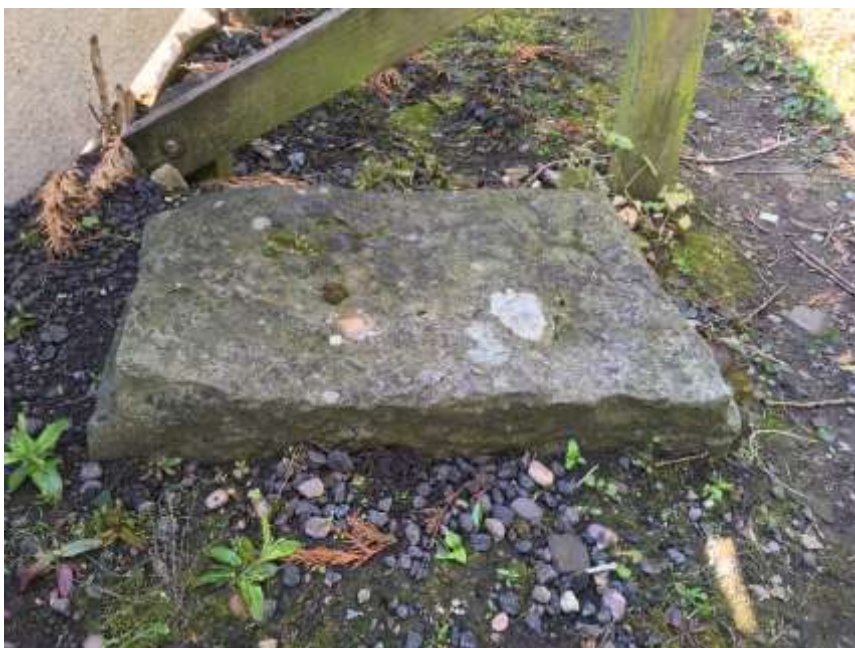
The vertical flat stone can be seen lying down nearby. It two opposite edges that have been stepped down, to fit into the grooved channels in the vertical posts. An initial measurement confirmed that the width of the flat stone corresponds to the gap between the two vertical posts.

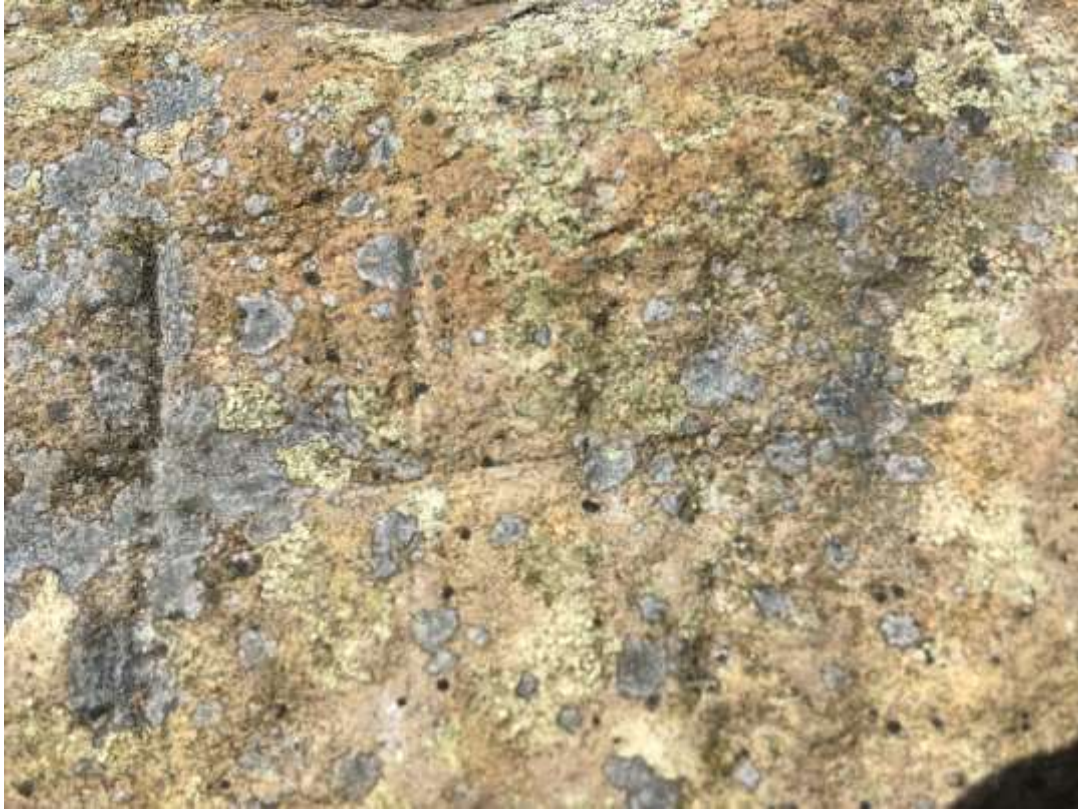
As at Matthews Lane, the third vertical post also has markings on its top surface:-

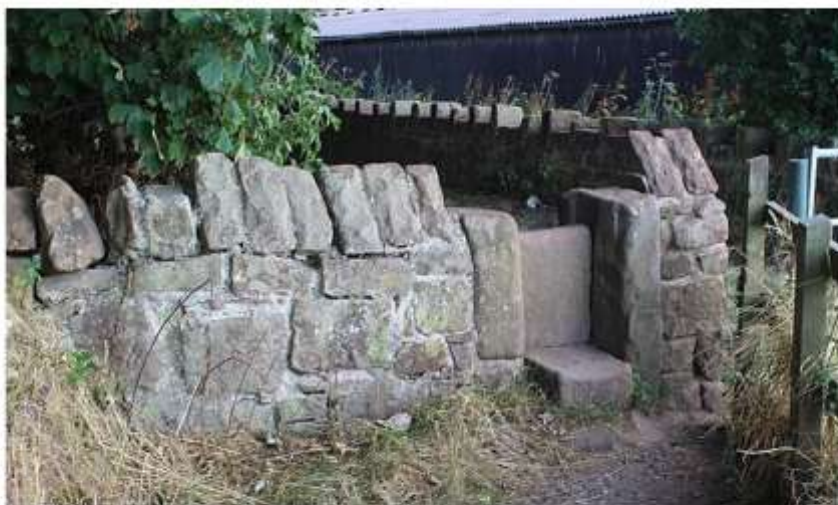
This one had the grooves extending to the top of the vertical posts, so that the vertical flat stone could be added or removed at any time.

For comparison, this is the Merseyside stone style, with its 'slot-in' vertical flat stone:-
